WL-TR-97-2053

THIN DENSE CHROME BEARING INSERTION
PROGRAM

GE AIRCRAFT ENGINES
ADVANCED ENGINEERING PROGRAMS DEPT
ONE NEUMANN WAY
CINCINNATI OH 45215-6301

FINAL REPORT FOR 03/01/92-12/01/96

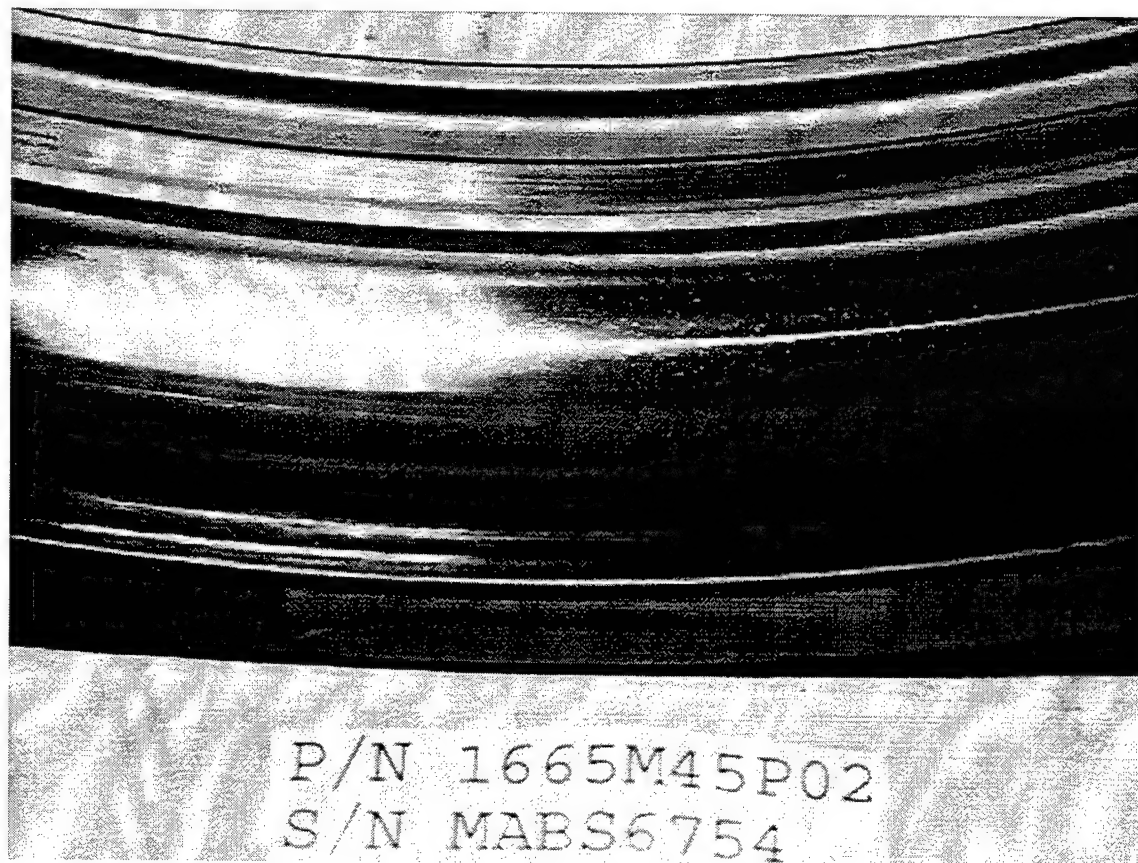
Figure 118. Photo of Contamination Tested TDC Bearing.
TDC coated bearings demonstrated superior contamination resistance.

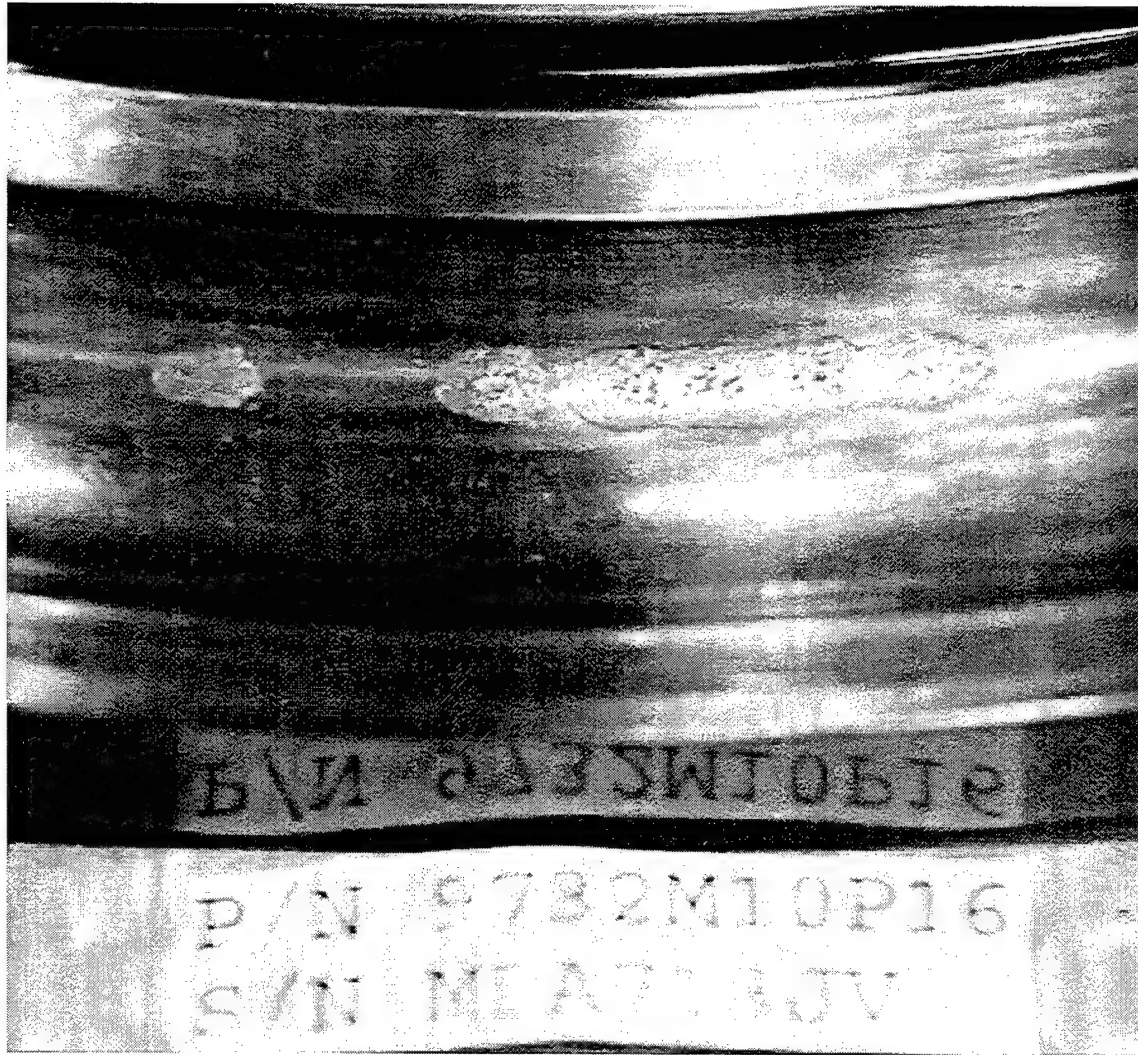
Figure 120. Photo of Outer Race Spalling on Bare, Contamination Tested Bearing.
Bare bearings repeatedly demonstrated less resistance to contamination.

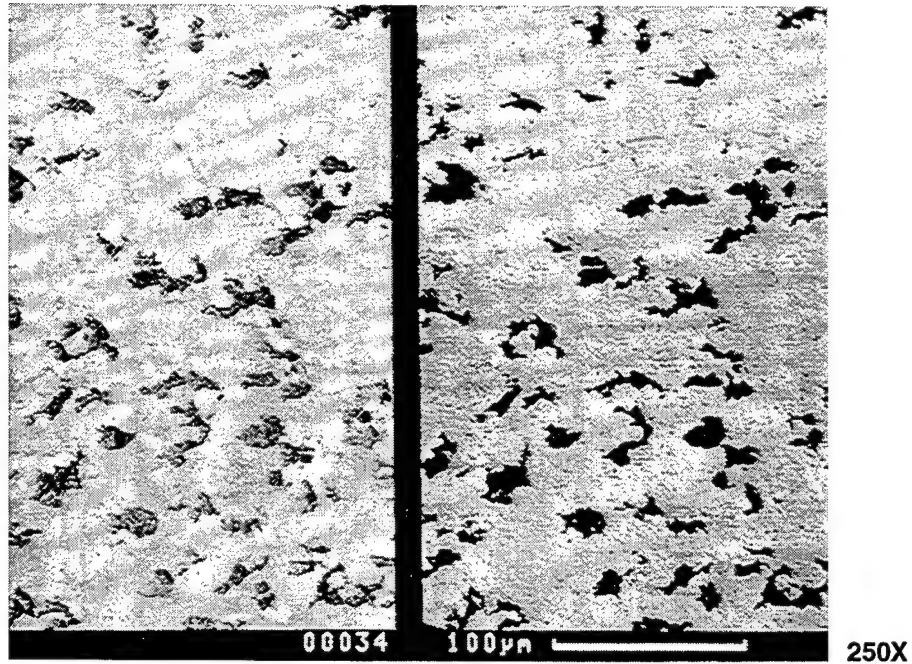
Figure 122. Microphotograph of Skid Damaged Inner Race TDC on Bearing S/N MDACE700.
Light colored areas in the left image highlight the smeared M50 from the balls. Dark areas in the right image indicate partial TDC pull out.

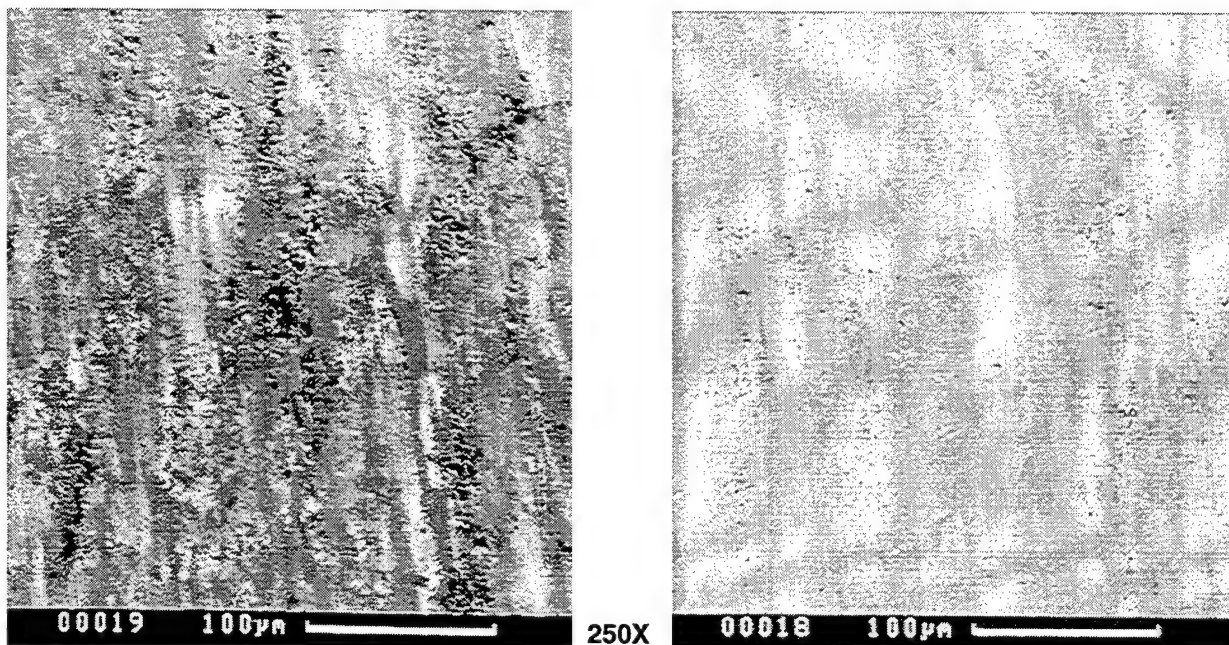
Figure 123. SEM Photograph of Skid Damaged Ball on Bearing S/N MDACE700.
Carbides (lighter areas) in the right photo appear to be broken up and smaller than undamaged areas of the ball.

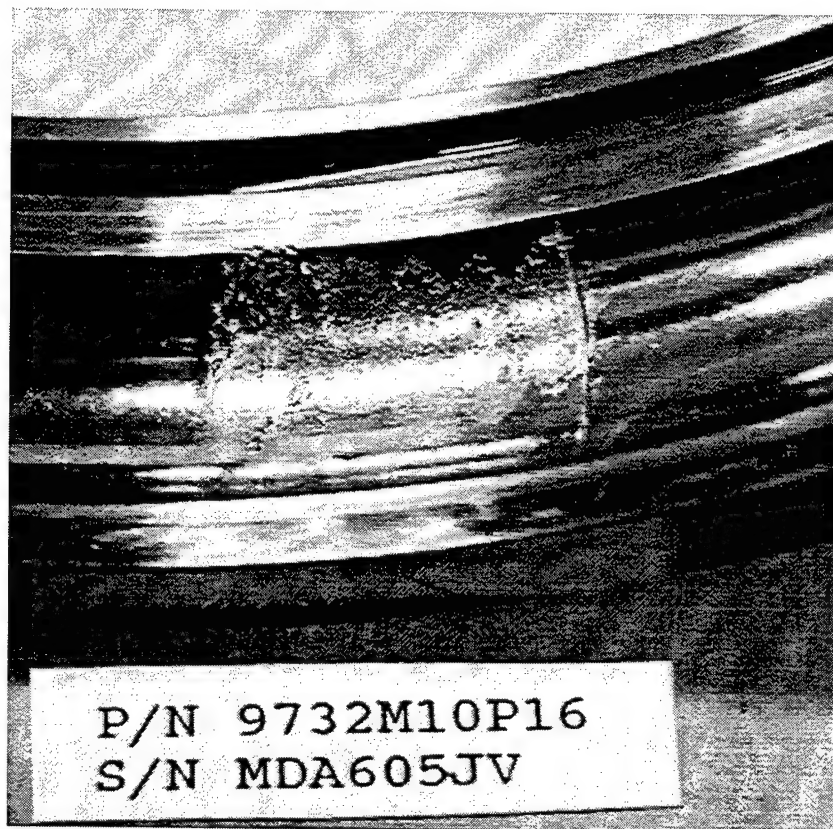
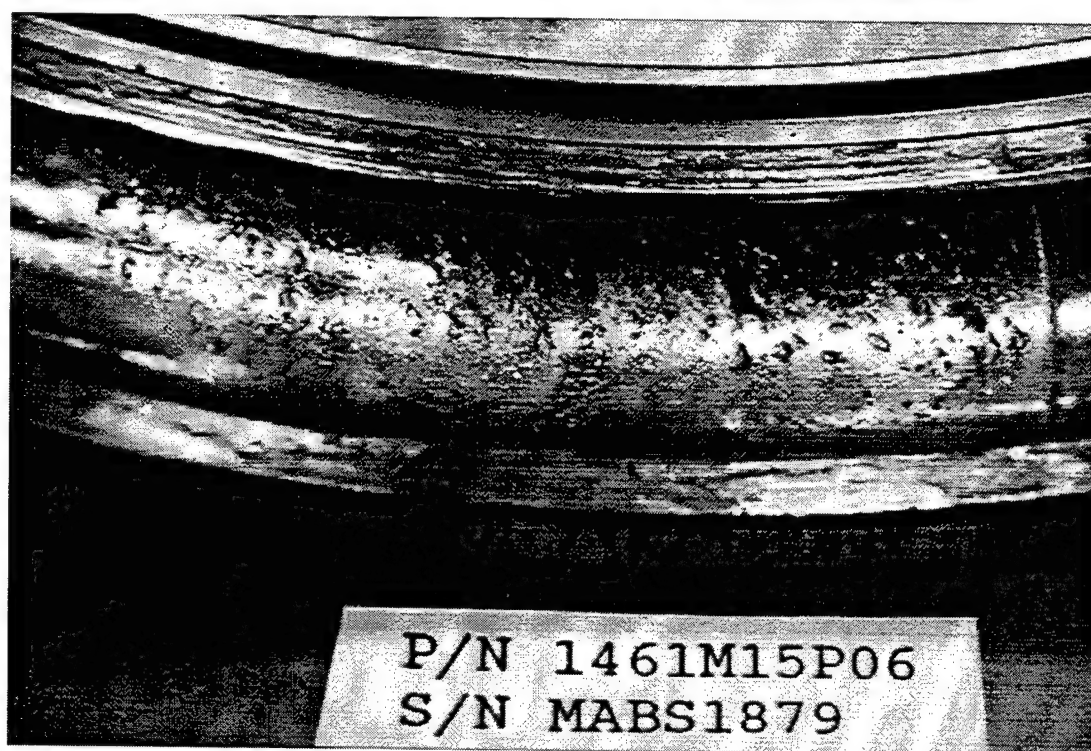
Figure 125. Photos of Plain Bearing Race Damage Evident after Induced Defect Test.

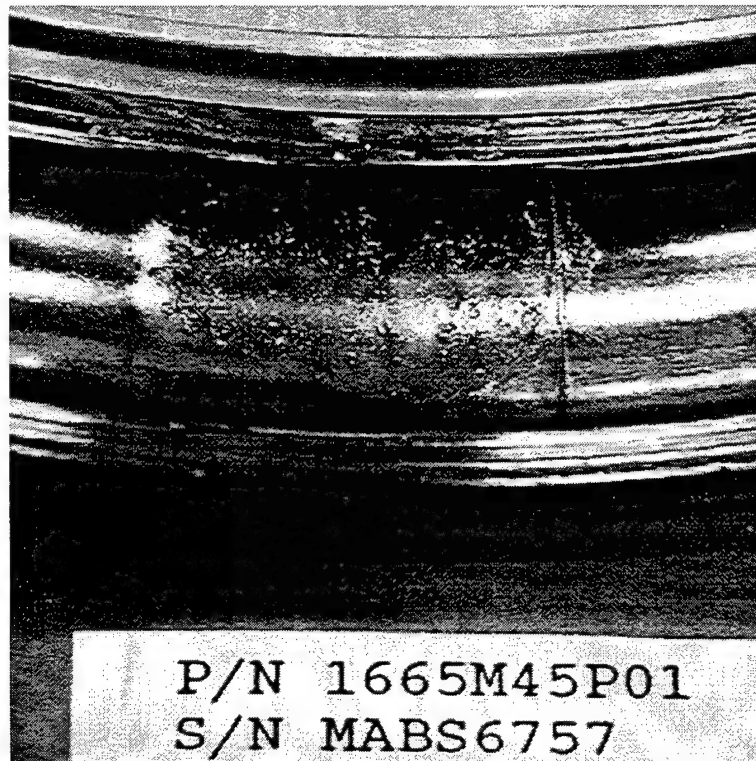
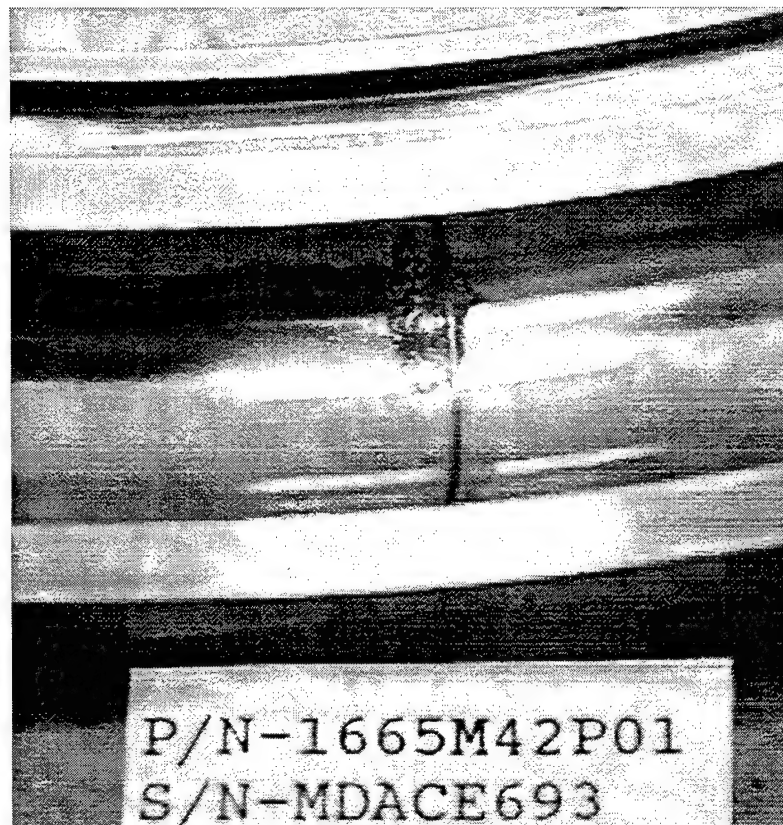
Figure 126. Photos of TDC Coated Bearing Race Damage Evident after Induced Defect Test.
Note reduced level of damage compared to plain bearings Figure 125.

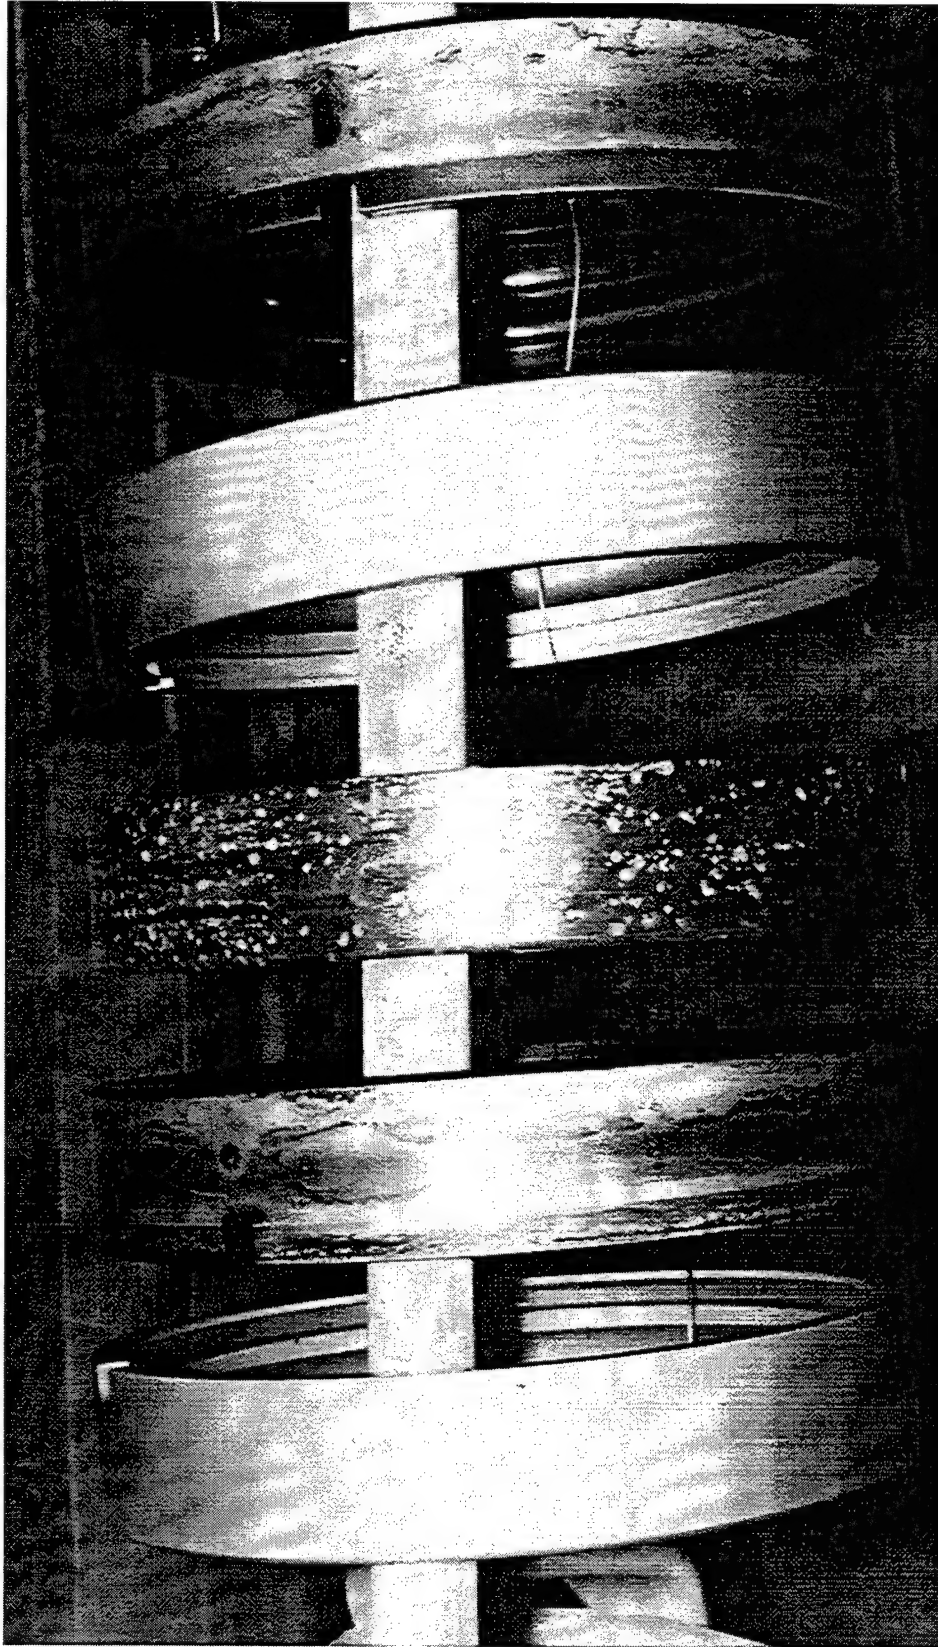
Figures 127 and 128 illustrate the conditions of the test races after atmospheric exposure. As evidenced by these photographs, the TDC coating provides a significant increase in corrosion resistance compared to plain bearings.

Figure 127. Photos of Corrosion Resistance Test Bearings.
TDC coating significantly improved corrosion resistance.

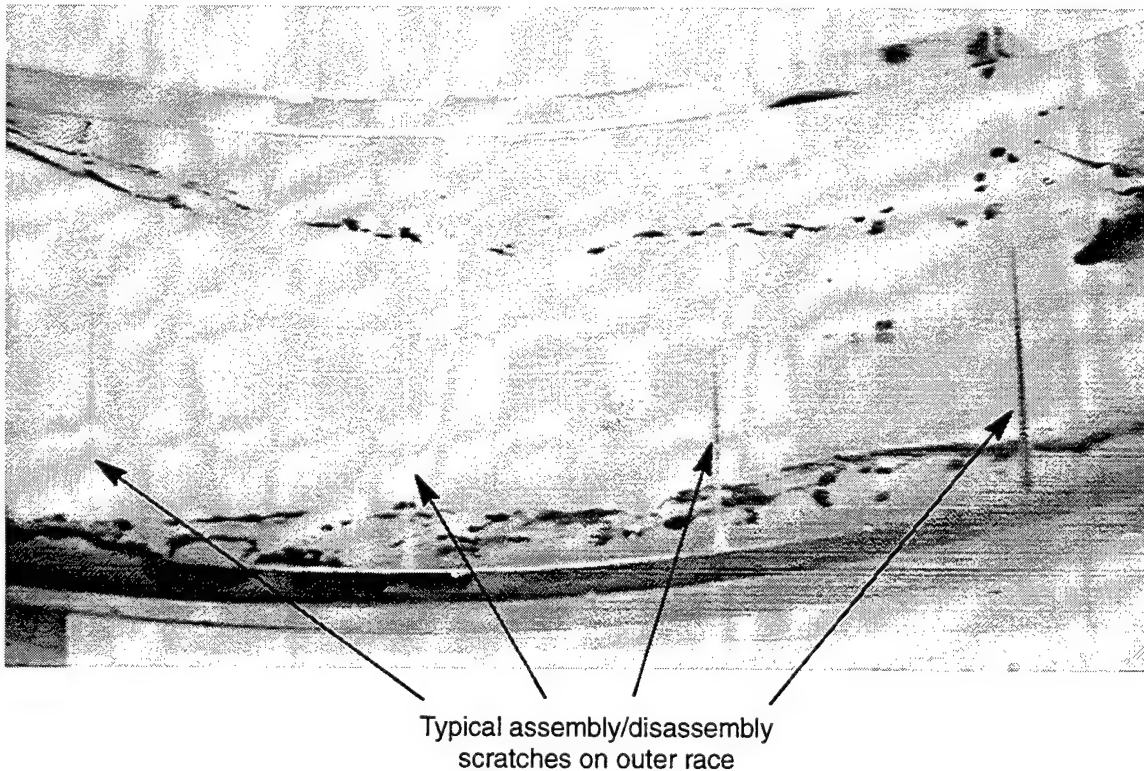
Figure 129. Photo of F110 No. 4R Bearing Outer Race TDC Coating Assembly Damage.

TDC coating of the No. 4R bearing was not recommended due to the increased susceptibility to assembly damage.

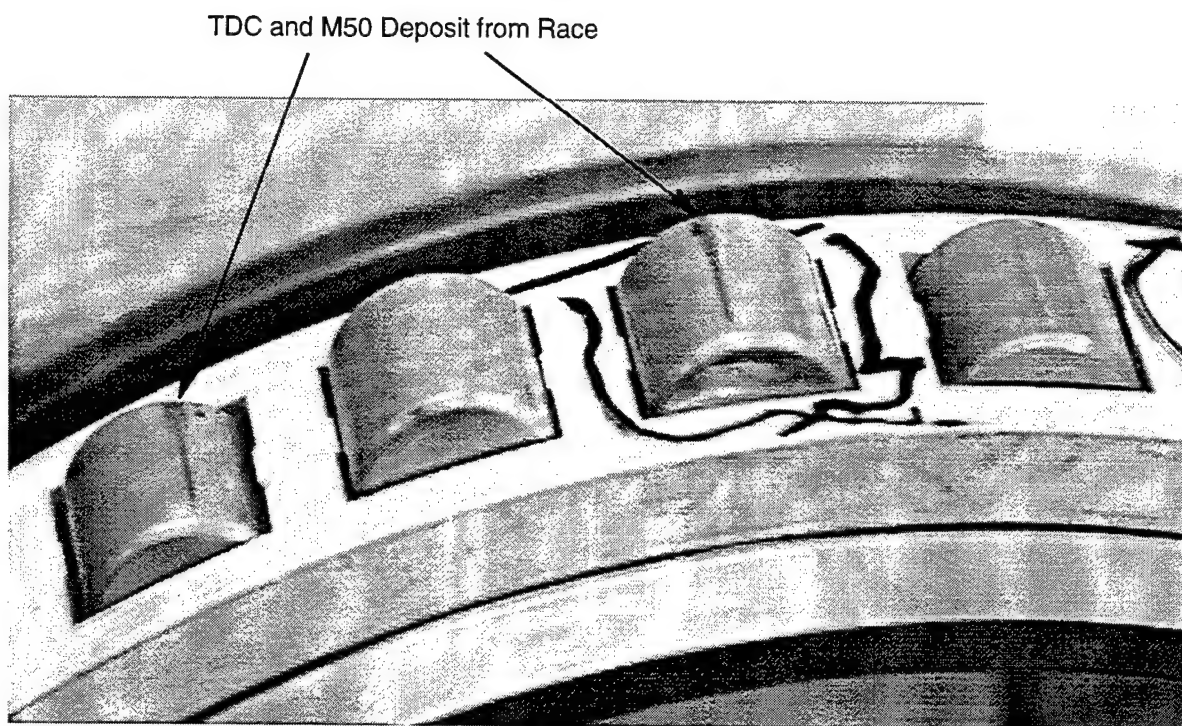
Figure 130. Photo of Assembly Damage to Roller TDC Coating.

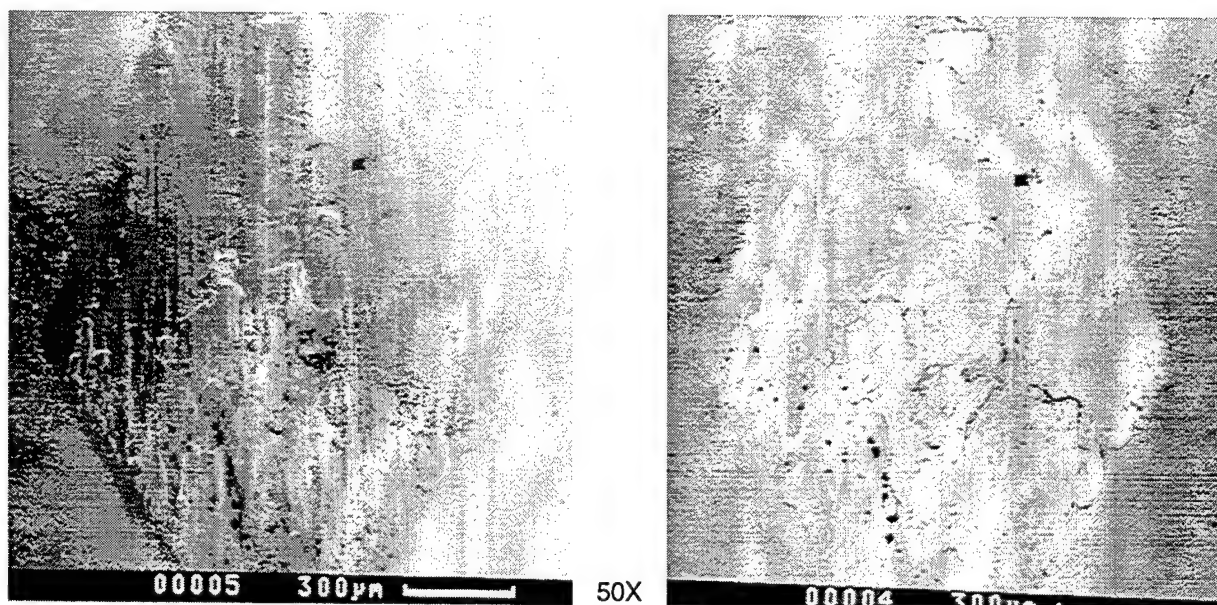
Figure 131. SEM Secondary and Backscatter Photos of Roller Assembly Damage.
Smeared areas indicate M50 material deposited from the race.

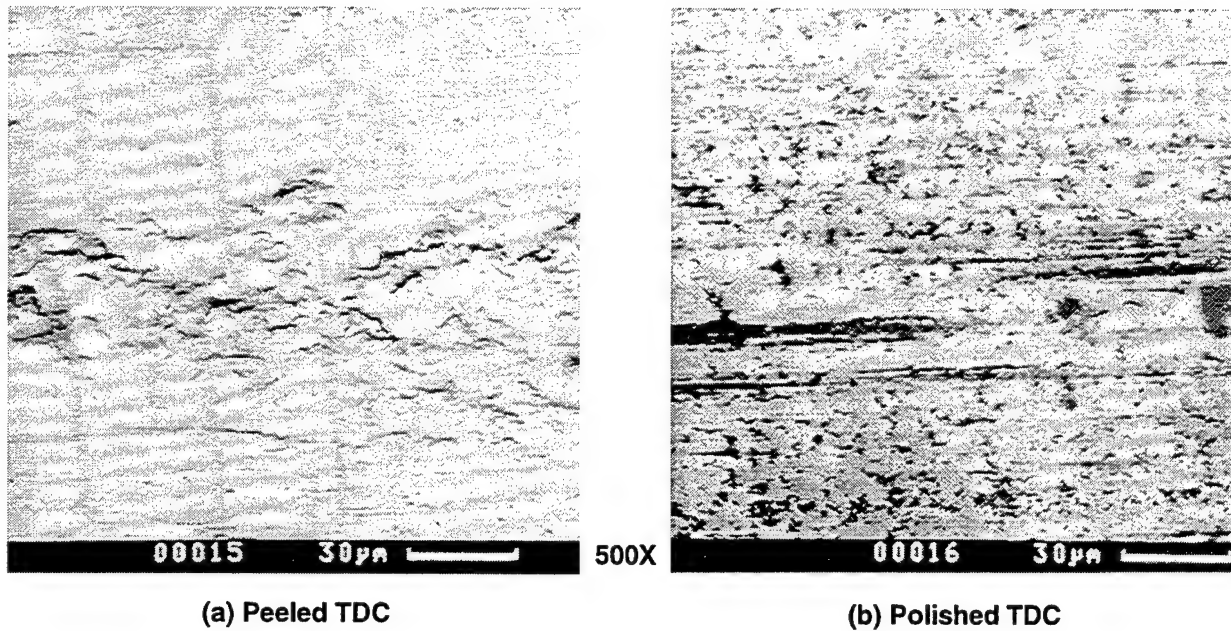
Figure 134. SEM Backscatter Photos of No. 5 Bearing Inner Race Damage.
TDC coating is susceptible to peeling as evidenced in test of ESN 538-103/4 bearing.

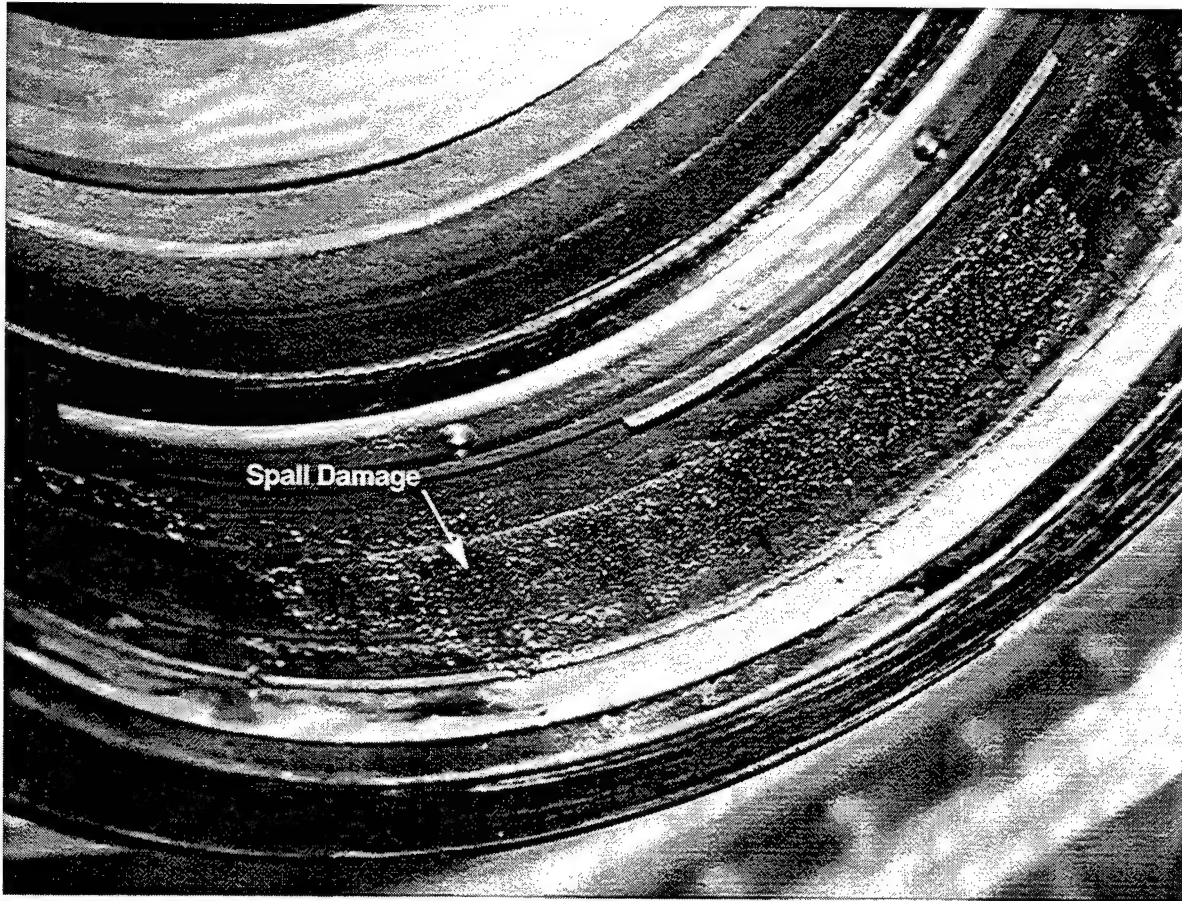
Figure 136. Photo of F110-GE-100 ESN 509-716/5 No. 4R Bearing Outer Race Spall.

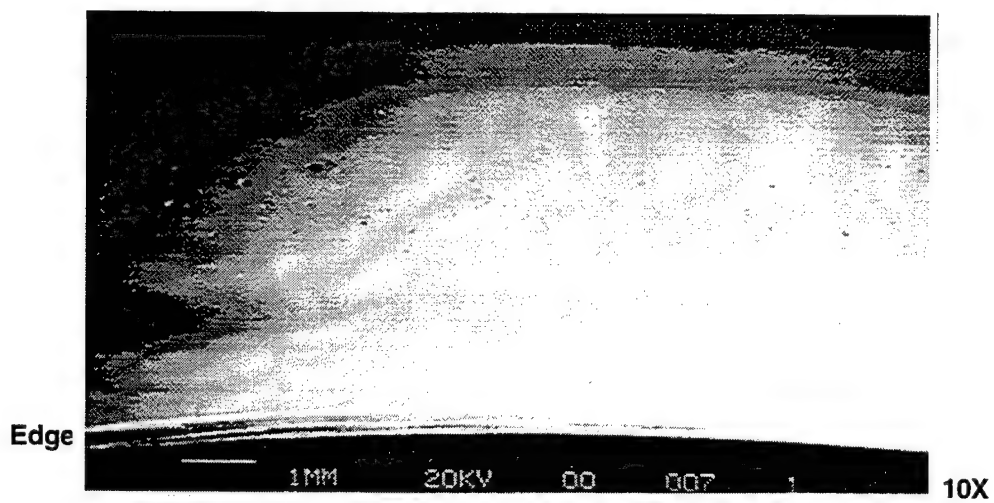
Figure 137. SEM Photo of F110-GE-100 ESN 509-716/5 No. 2B Bearing Inner Race.
Note band of dimples indicating micropeeling.

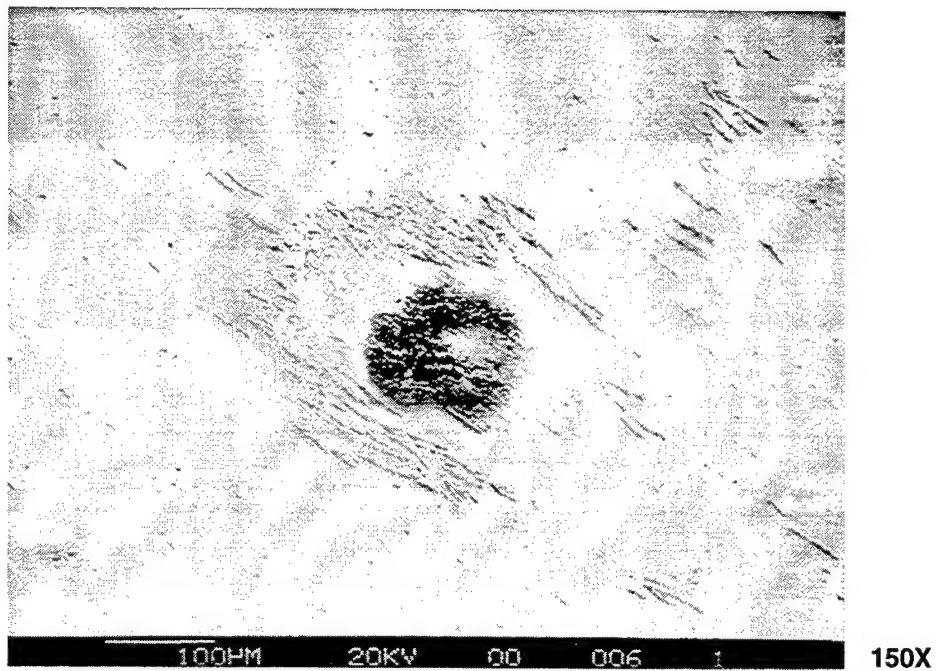
Figure 139. SEM Backscatter Photo of F110-GE-100 ESN 509-716/5 No. 1R Bearing Inner Race. *TDC micropeeling results in secondary damage.*
